December 14, 2020

RE: 3 Avenue La, Anytown, CT.

On December 10, 2020 we visited the above referenced location to visually assess the existing residential structure for signs of any significant structural damage and/or distress. This inspection was limited to structural components accessible at the time of the inspection. The following were our findings:

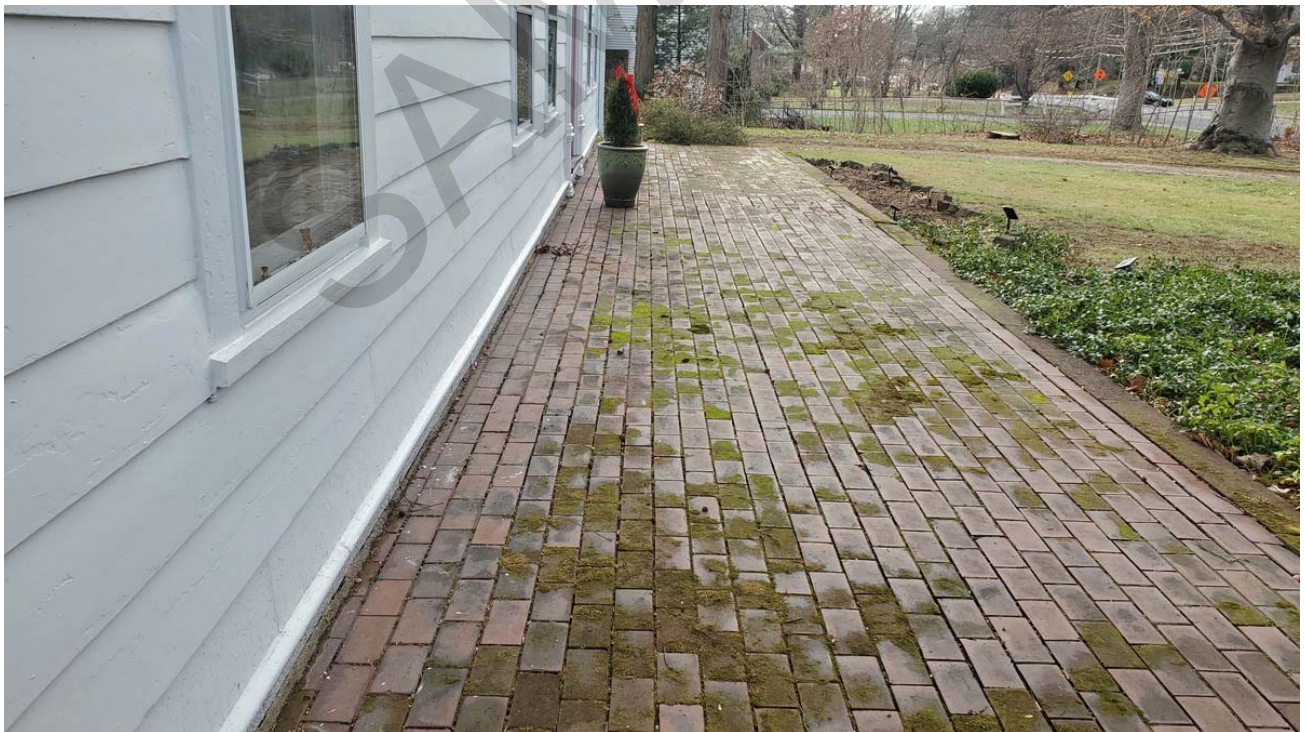
At the west side of the structure there is a large un-mortared brick patio area which is flat or pitched slightly toward the structure. This may allow water to be directed toward the structure.

Brick patio may direct water toward the structure.

Grading should be modified to provide a minimum 5% slope away from the building. The brick patio at the western side of the structure is leading water toward the foundation as evidenced by the water infiltration in the basement through the foundation walls. This patio will should be removed and the grade reconfigured providing the minimum required slope. The patio can then be re-constructed in a way that leads water away from the structure.

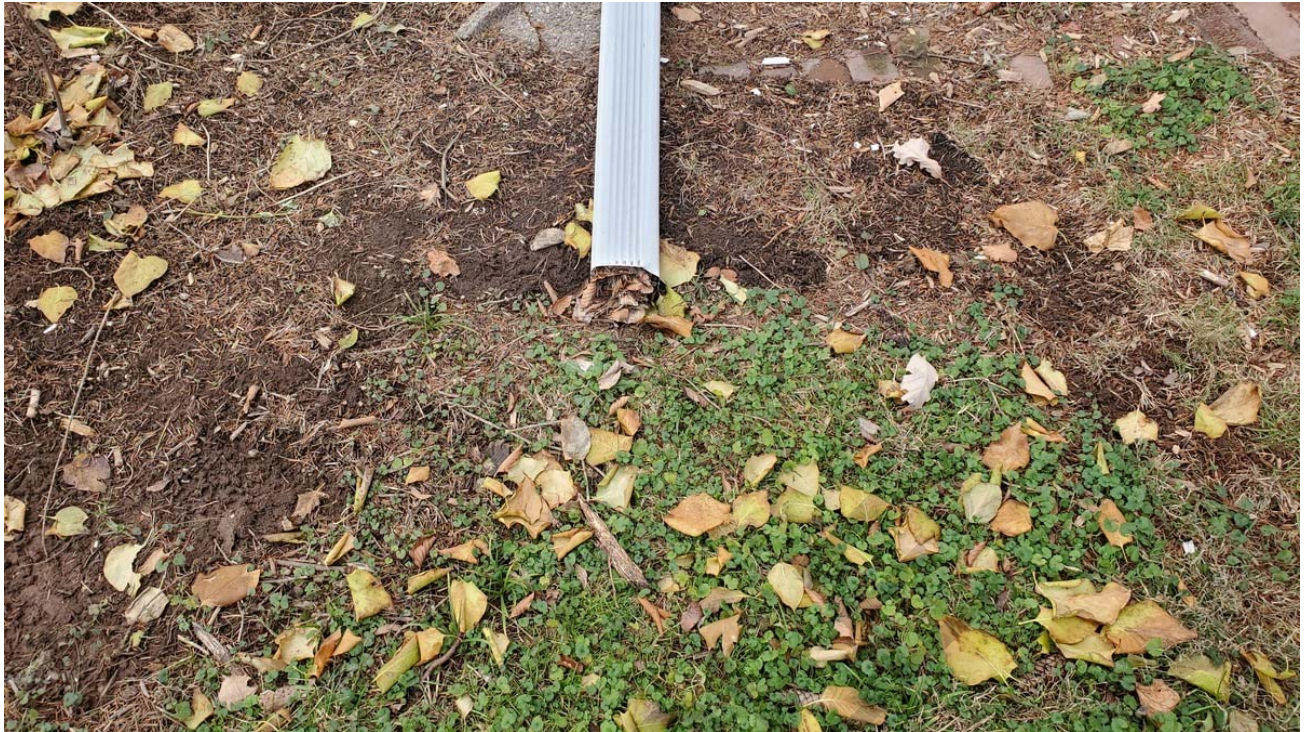
Many of the existing downspouts have been extended to deliver water away from the foundation, however two of these extensions were observed to be clogged. (Key Plan Observation Item #1)

Downspouts observed clogged in some locations.

All drainage systems, gutter systems and downspouts should be cleaned out and have their functionality verified.

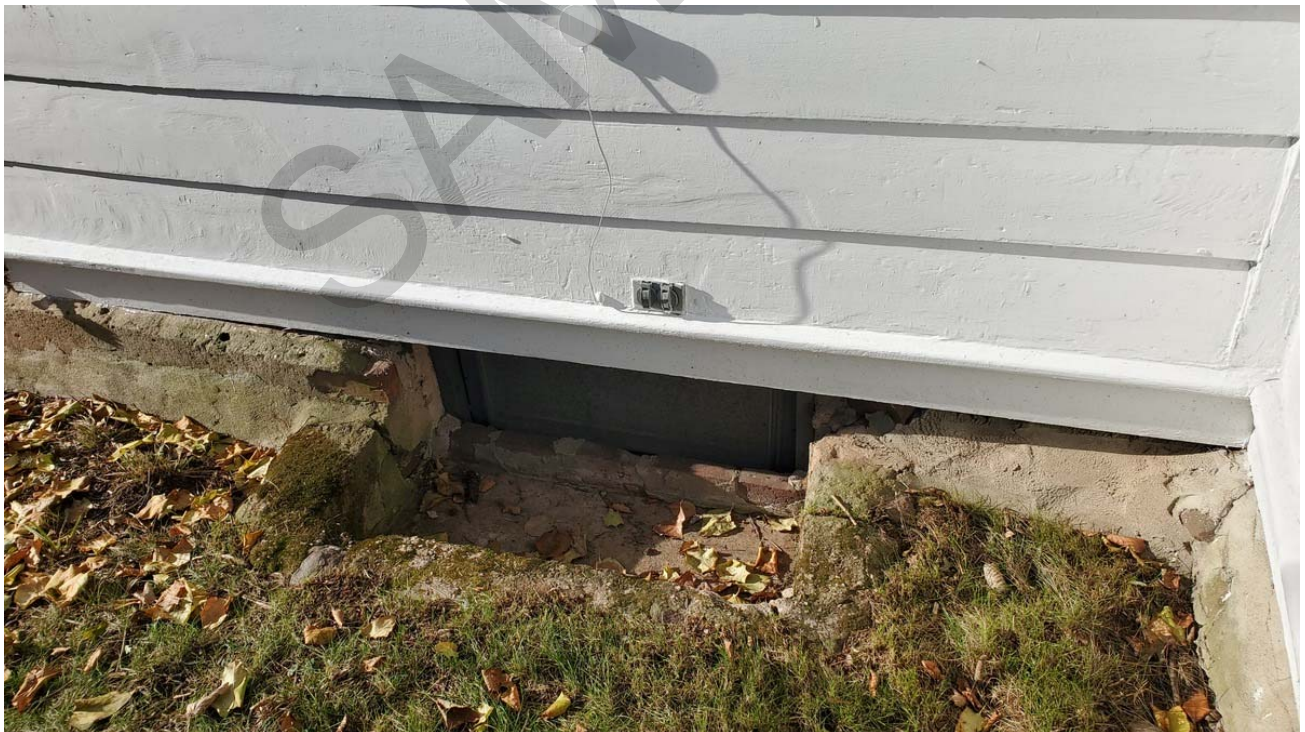
Basement window wells are low; current surrounds may direct water into the basement.

Low windows wells may allow water entry into basement.

Surrounds around window wells should be raised if possible.

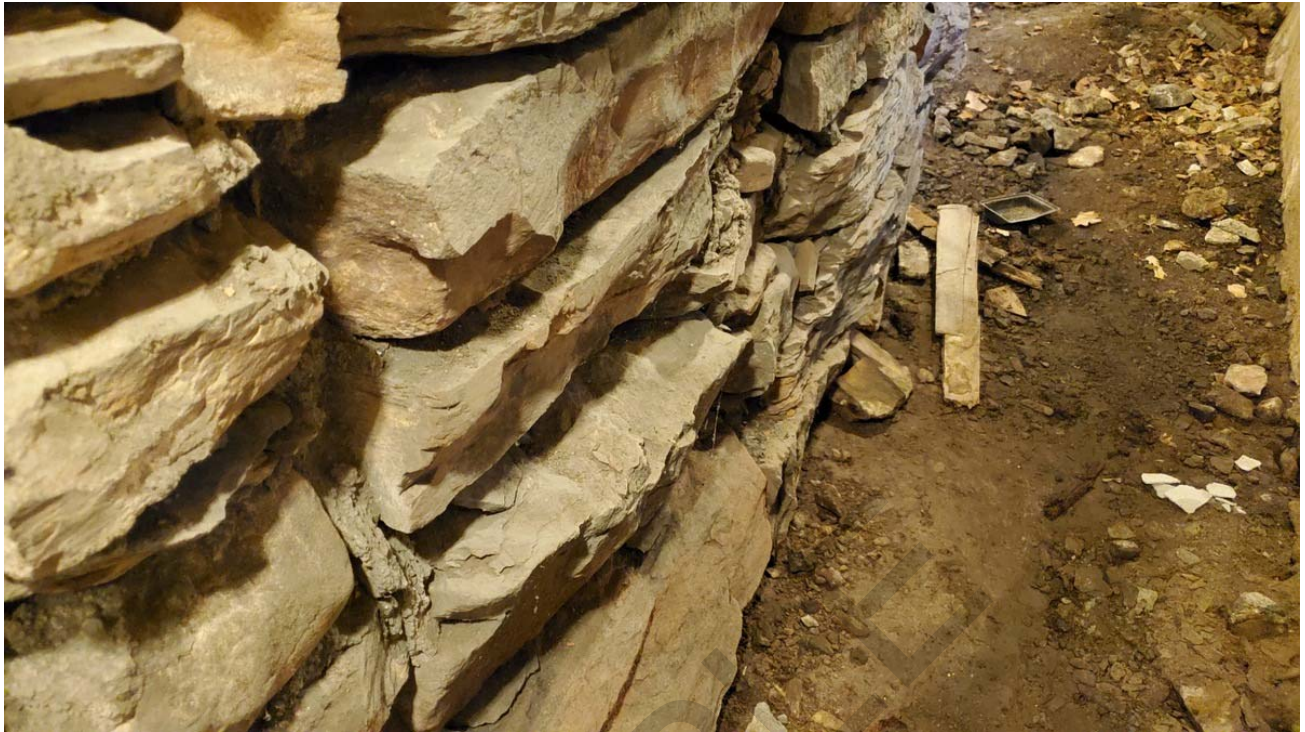
In general, the mortar for this foundation is in need of attention. Voids and cracks exist in the existing mortar along all walls. In areas the mortar has failed and can be seen on the basement floor. (Key Plan Observation Item #6) In one area, it appears mortar has been removed in a possible start to re-pointing.

Re-pointing of the stone foundation is required.

All foundation walls for this structure will require re-pointing. A qualified mason should be consulted to determine the extent of failed mortar, remove as necessary, and re-point the entire foundation. **Of particular concern is the undermined portion of the west foundation wall.*** At the time of inspection, the upper section of this wall has not become affected, however, if this condition is not corrected, may lead to significant failure of this wall. Mitigation of the water conditions on the exterior of this wall by re-grading the front patio or otherwise re-directing runoff water will be key in preventing continuation of this deterioration.

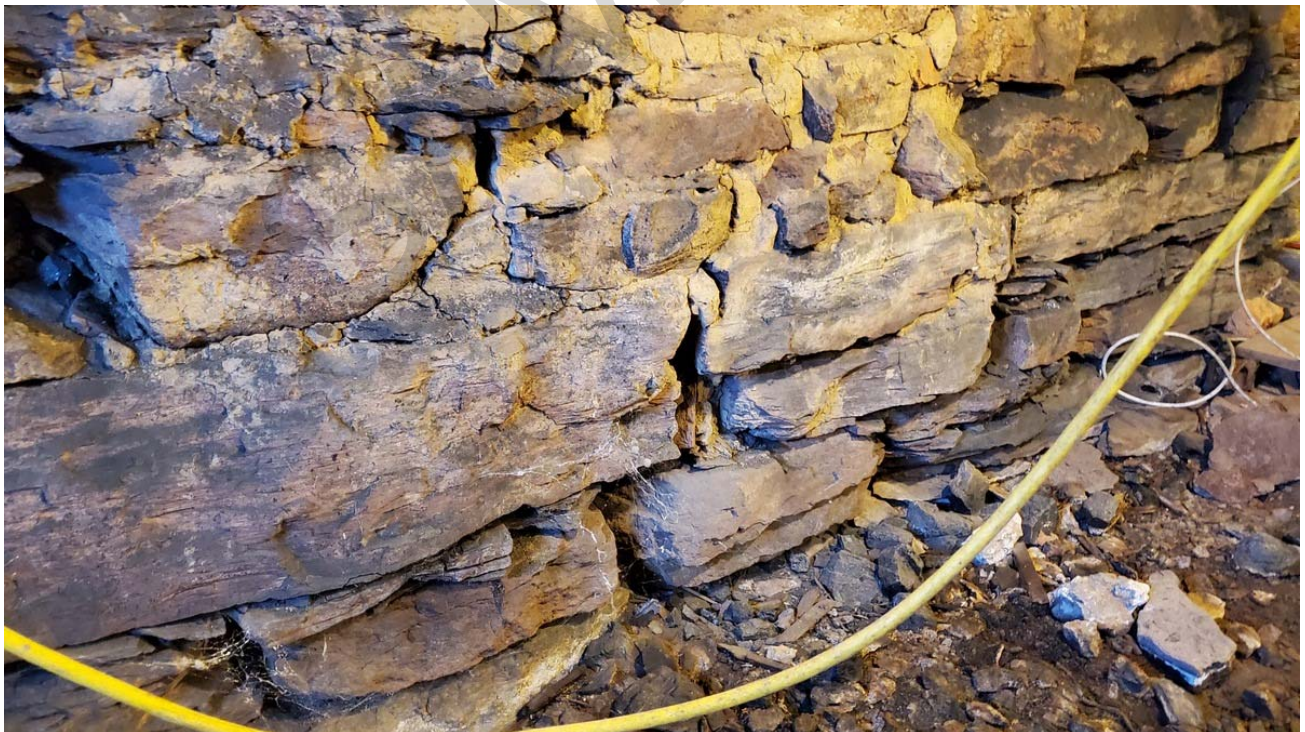
Re-pointing of the stone foundation is required.
Some mortar is soft and deteriorated.

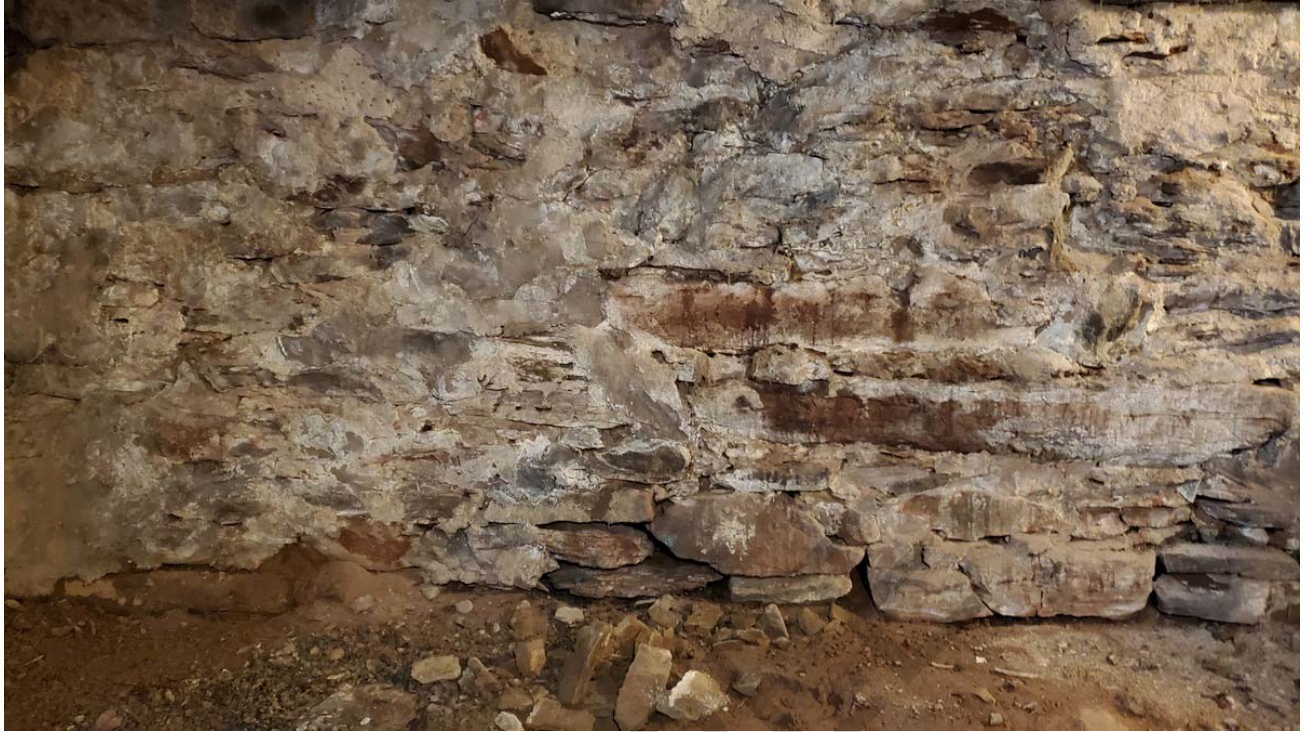
In the southwest corner mortar for the foundation is soft, wet, and disintegrating. Evidence of heavy water infiltration was observed in this area. Portions of the west foundation wall were visibly wet, and water infiltration has affected the base of this wall. A portion of the western wall is undermined, stones are missing from the base of this wall. (Key Plan Observation Item #9)

Water infiltration in the southwest corner has caused mortar failure.
A section of the wall has become undermined.

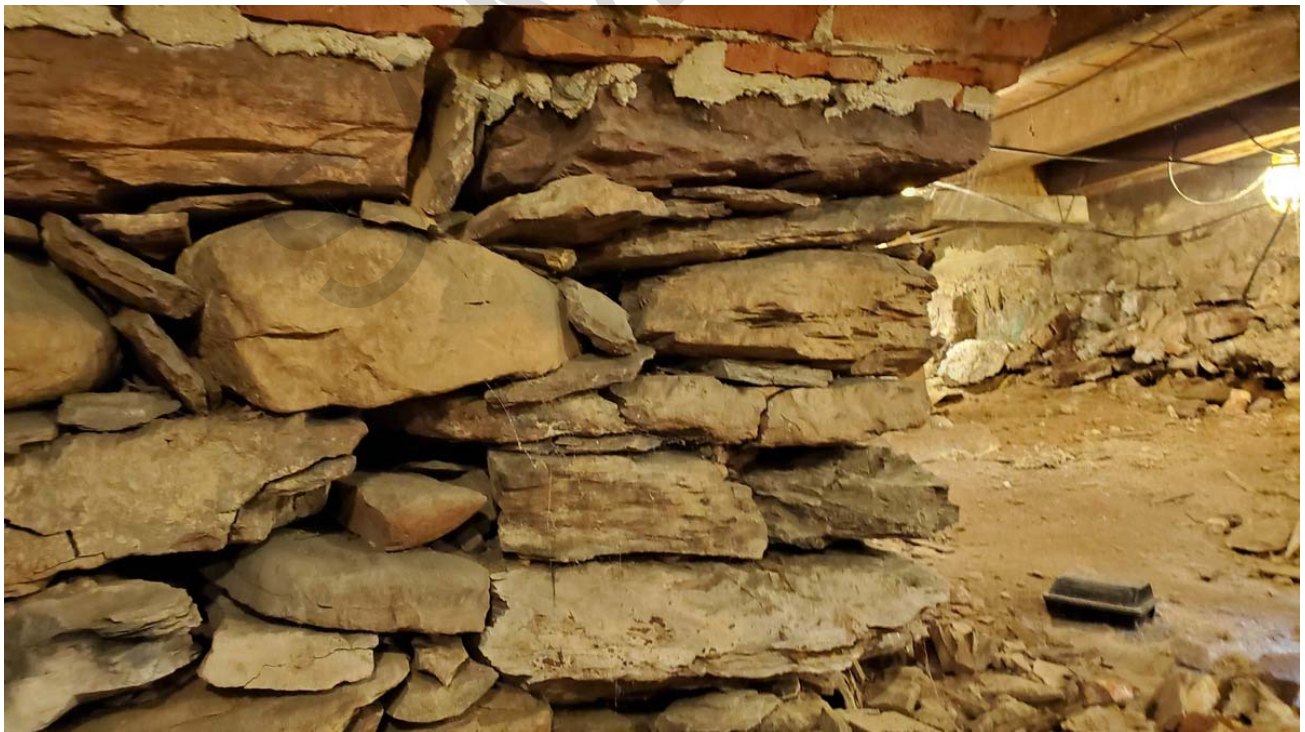
Cracks were observed in the foundation for the southern chimney. Prominent cracks exist in both the southeast and northwest corners of this chimney's foundation, an indication that settlement or movement has occurred at some time in this chimney. This settlement has allowed some bricks for the hearth above to separate. (Key Plan Observation Item #7, #8)

Cracks in the stone of the southern chimney foundation. (North face)

The settlement in the foundation for the south chimney are likely related to movements in the loosely, or non-mortared stone. **Both chimneys should be re-mortared by a qualified mason, with experience in repairing stone foundations of this era.***

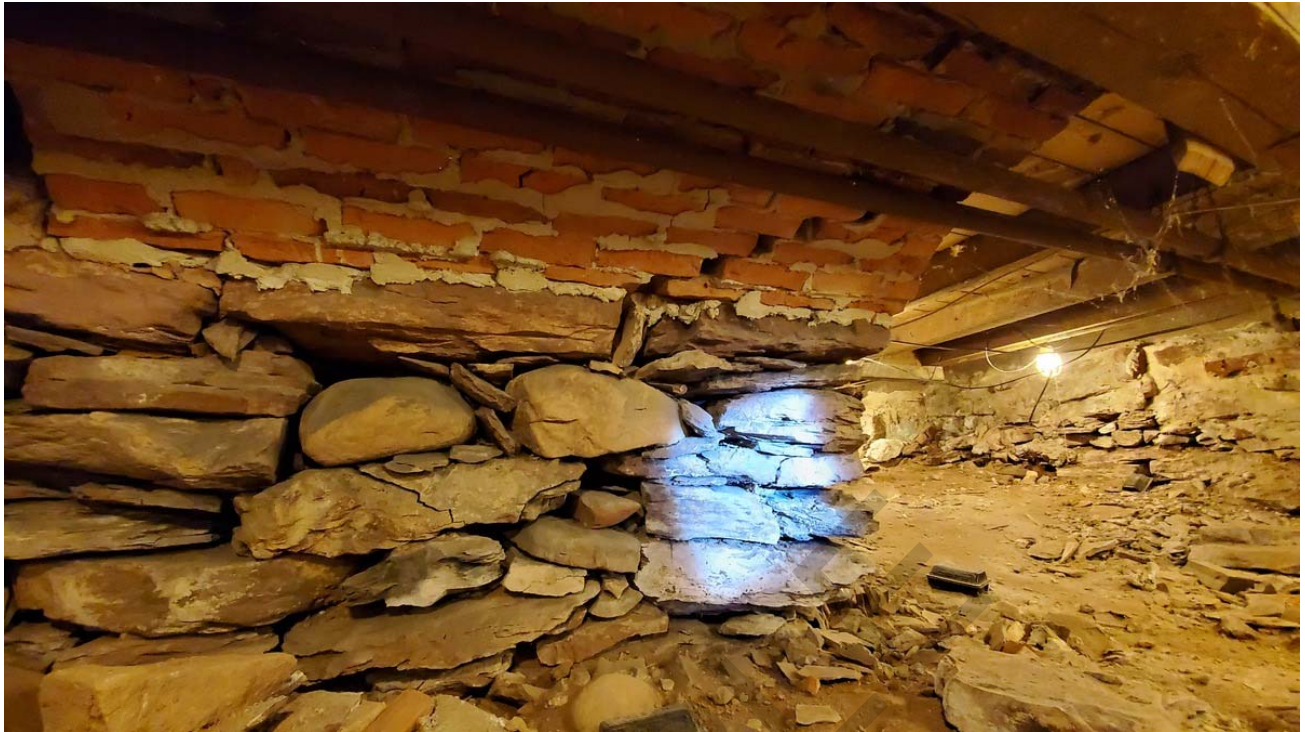
Separation of brick and un-mortared stone in southern chimney foundation. (North face)

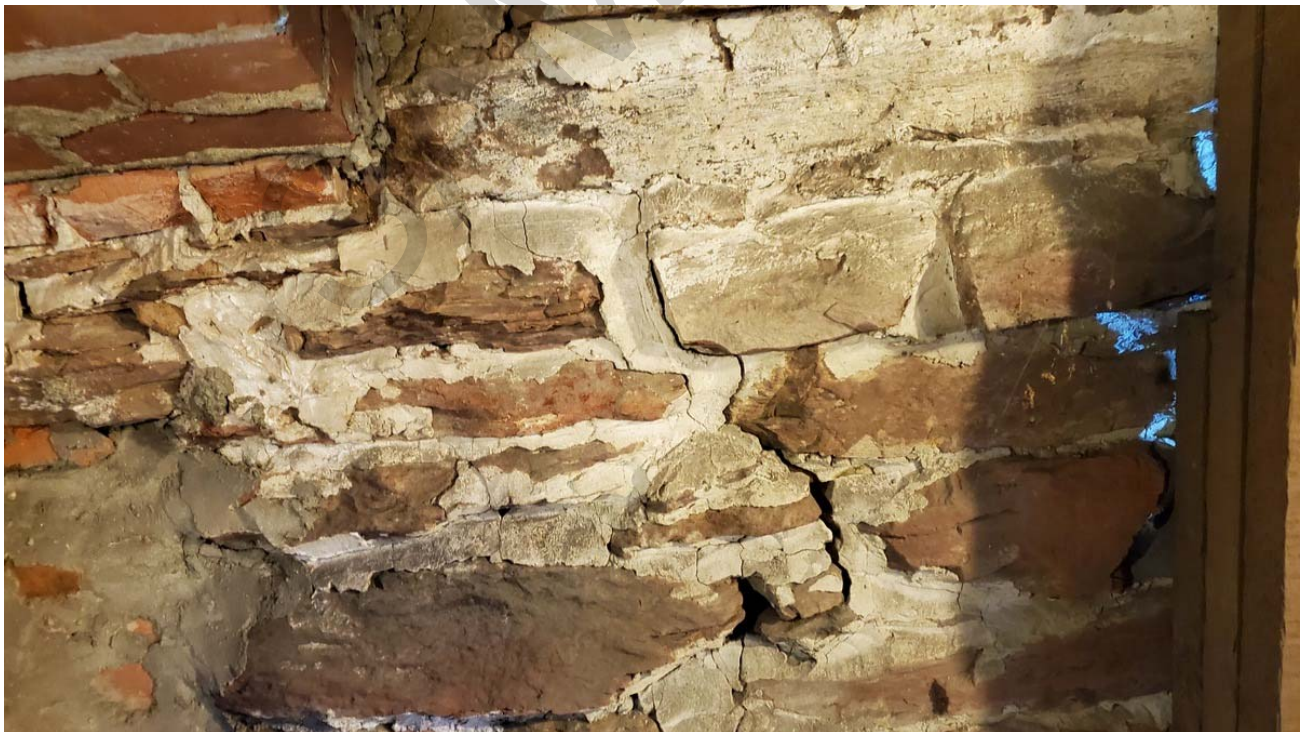
Cracks in the stone of the southern chimney foundation. (South face)

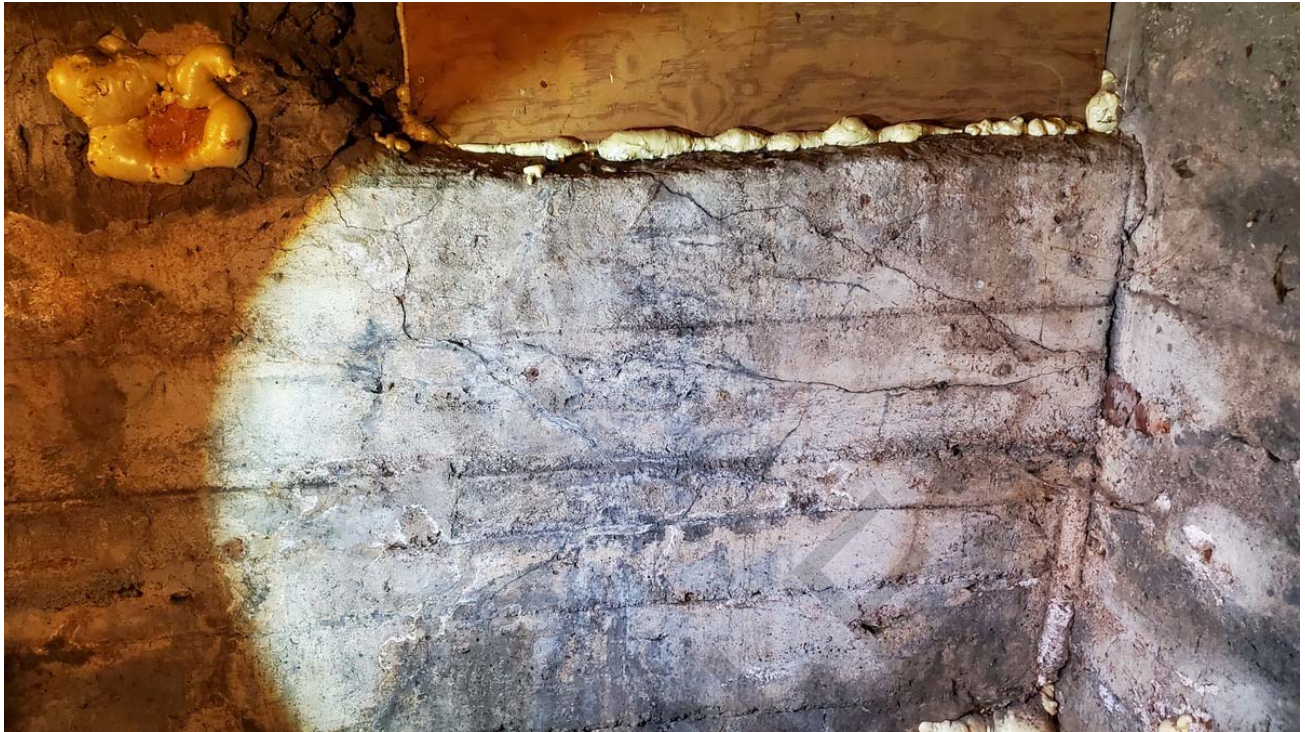
In the northeast corner, horizontal and diagonal cracks were observed in a small section of the north foundation wall. This section exists to the east of the opening which was cut through the north wall for the exterior stairs. This area of the foundation has had a heavy cementitious coating added to the interior.

Horizontal and diagonal cracks in foundation north wall, northeast corner.

The cracking in the heavily parged section of the north foundation wall is an indication that some movement has occurred in this section of the foundation wall. Interrupting this wall for the exterior stair passageway has lessened this wall's ability to support the weight of soil pressure applied to exterior. These cracks should be monitored, and if they increase in width, this wall may require additional support at the opening for the basement exterior stairway.

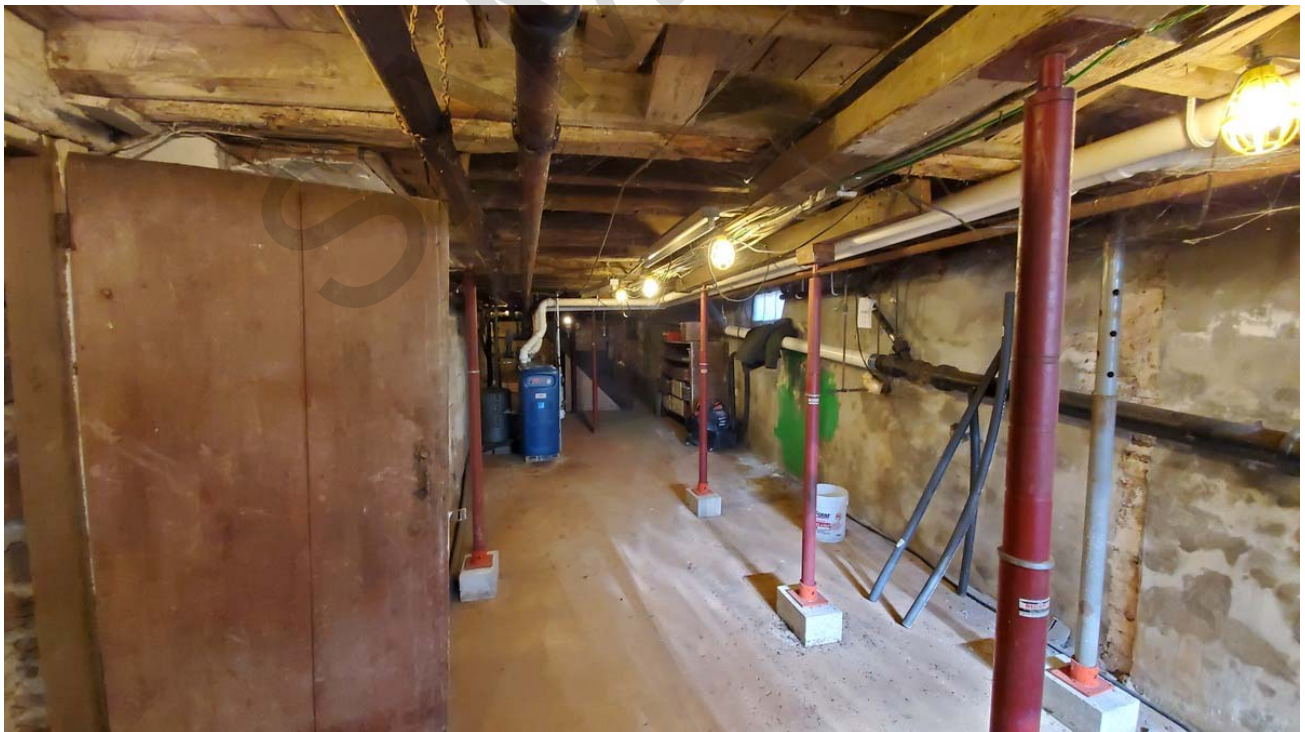
Deflections of the original framing were observed, as well as a series of adjustable columns supporting various portions of the floor framing in this area. (Key Plan Observation Item #10) Partial beams have been installed reducing the effective spans of the floor joists in this area; however these beams do not support every joist in this area, and the un-reinforced section deflects noticeably underfoot on the first floor level. (Key Plan Observation Item #12) Partial beams have been constructed in a “T” configuration using only one column for support.

Adjustable supports for non-continuous beams in basement.

Temporary supports have been added in this area in an attempt to reduce the spans of deflected floor framing members in this area. The line of support is not continuous, and some beams are not properly supported. We would recommend the addition of proper columns, beams and footings creating a continuous line of support reducing the span of these original floors joists. All "T" configuration supports should be reconfigured providing two columns for support.

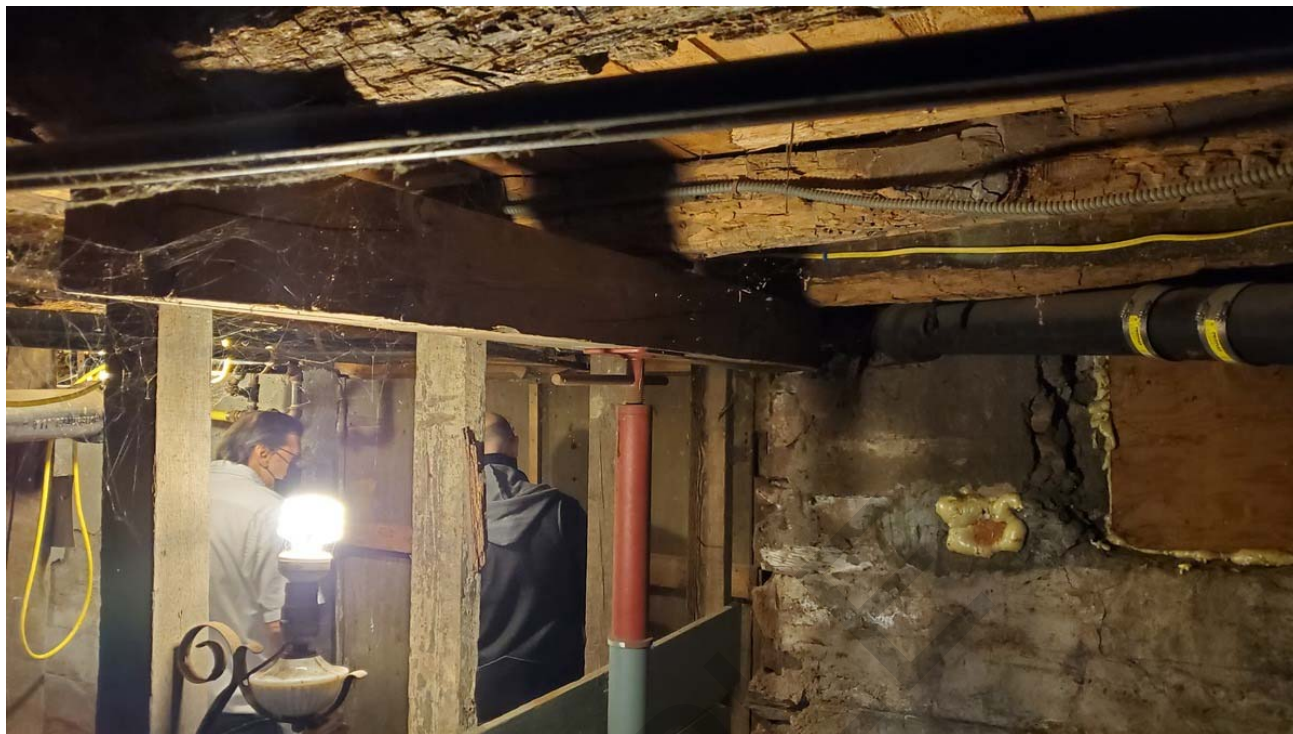
"T" style supports – Beams supported by single columns.

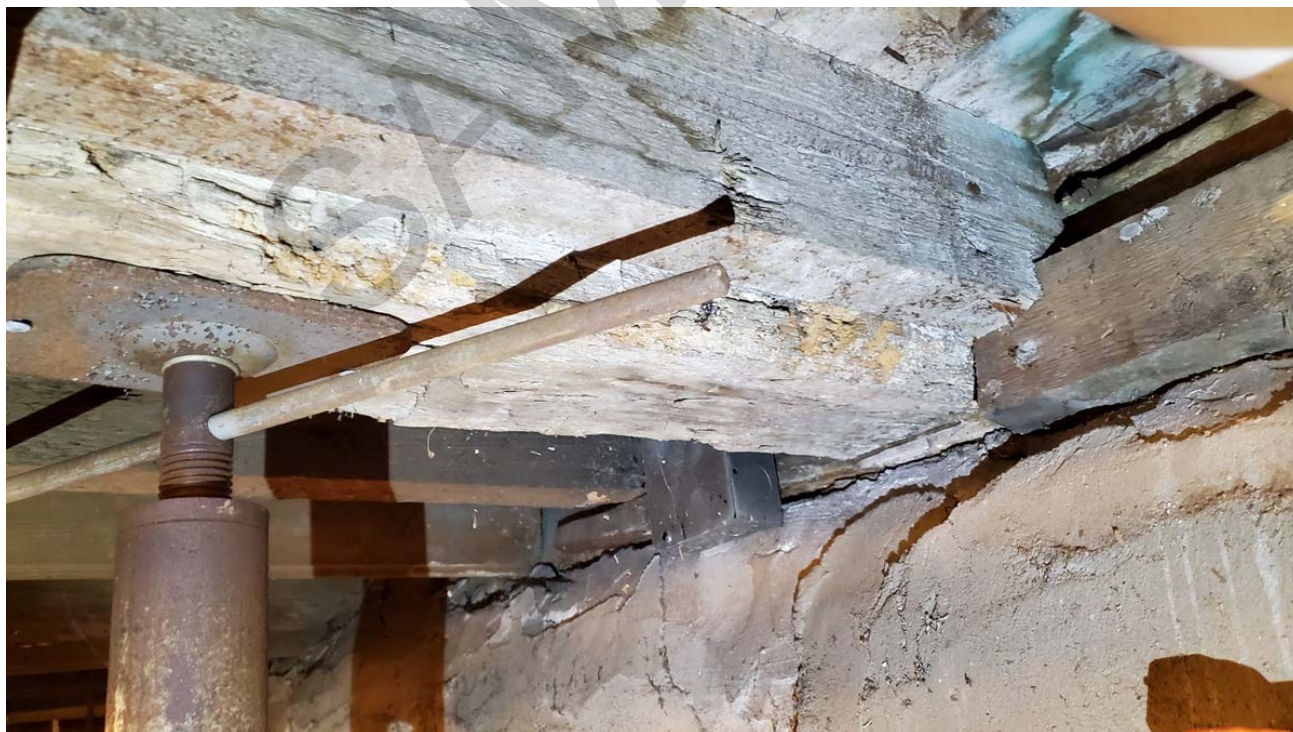
In this portion of the structure, many of the mortise and tenon style connections of the floor joists and intermediate beams to the perimeter beam, which sits atop the east foundation wall, have failed. Joists have pulled away from the perimeter beam due to deflection. Insect damage has affected many of these connections. Temporary supports have been added at some locations to prevent complete failure. (Key Plan Observation Item #3)

Failed framing connection along foundation east wall, with added temporary support.

The connections at the east wall, as noted, are failing. The addition of a support line of properly designed beams and columns along the east wall to support floor framing is recommended.

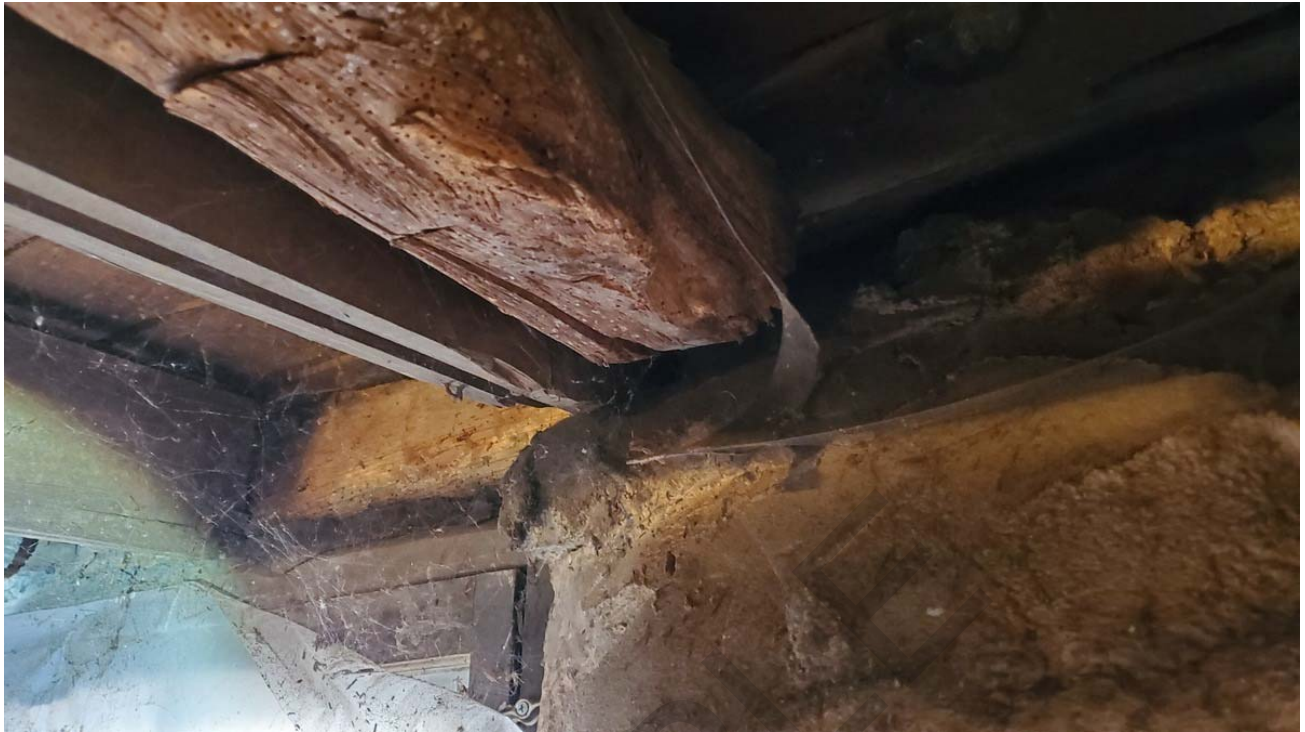
Failed framing connection along foundation east wall.

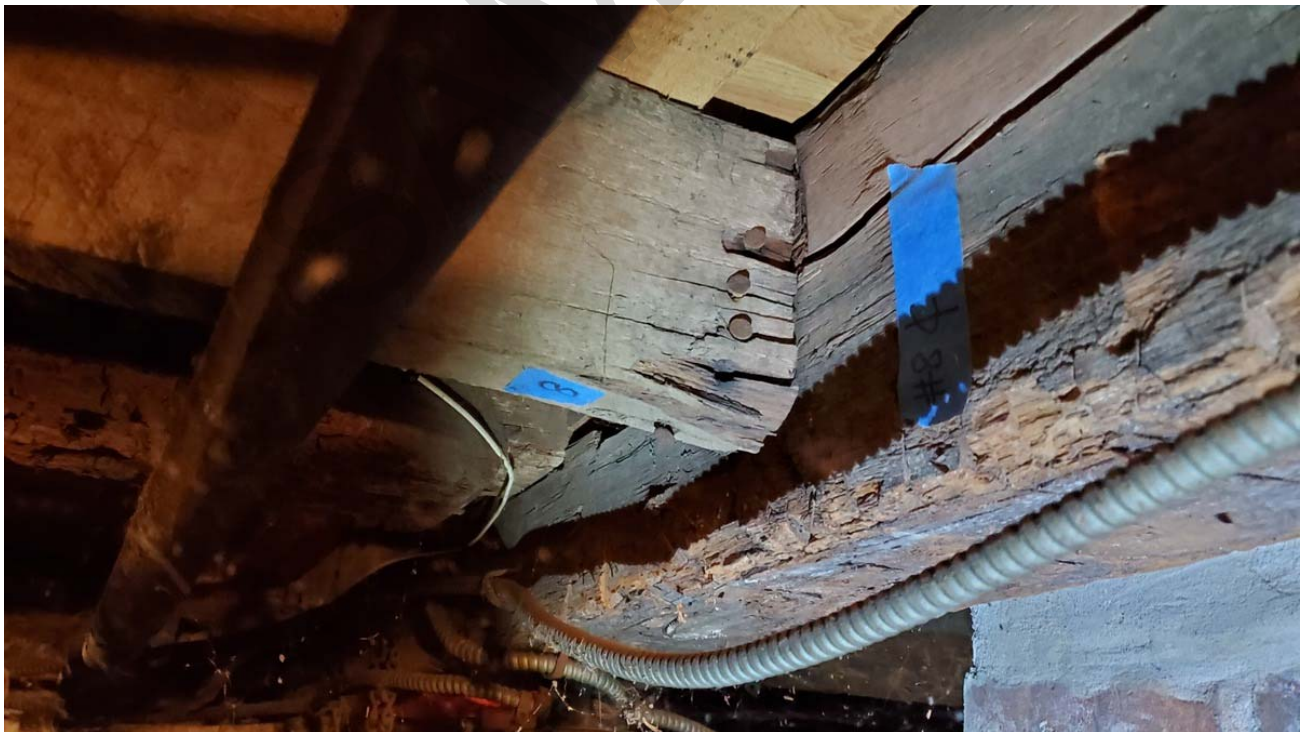
Improper / failing framing connection, first floor - floor framing.

All framing connections in this area should be inspected, as some mortise and tenon failures and connection failures were noted. Reinforcement of individual connections will be required. Improperly sistered beams will require proper sistering members designed and added. Extent of insect damage to framing members should be evaluated and members with extensive damage replaced.*

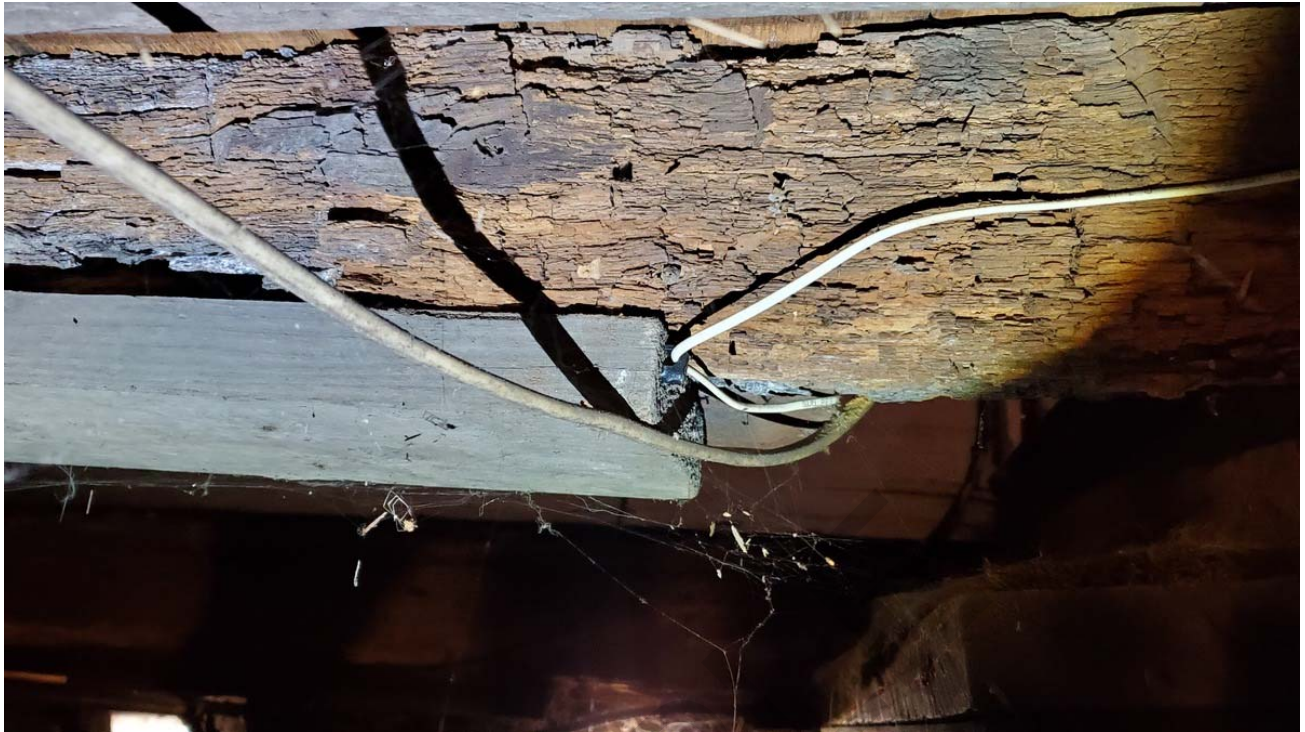
Some of the larger beams in the floor system have concerning deterioration from insect activity. An attempt to sister these beams has been made with what appears to be tongue-and-groove flooring sections. Limited probing of these beams revealed several locations where the structural integrity may be compromised. (Key Plan Observation Item #4)

Framing timber with insect damage, first floor - floor framing.

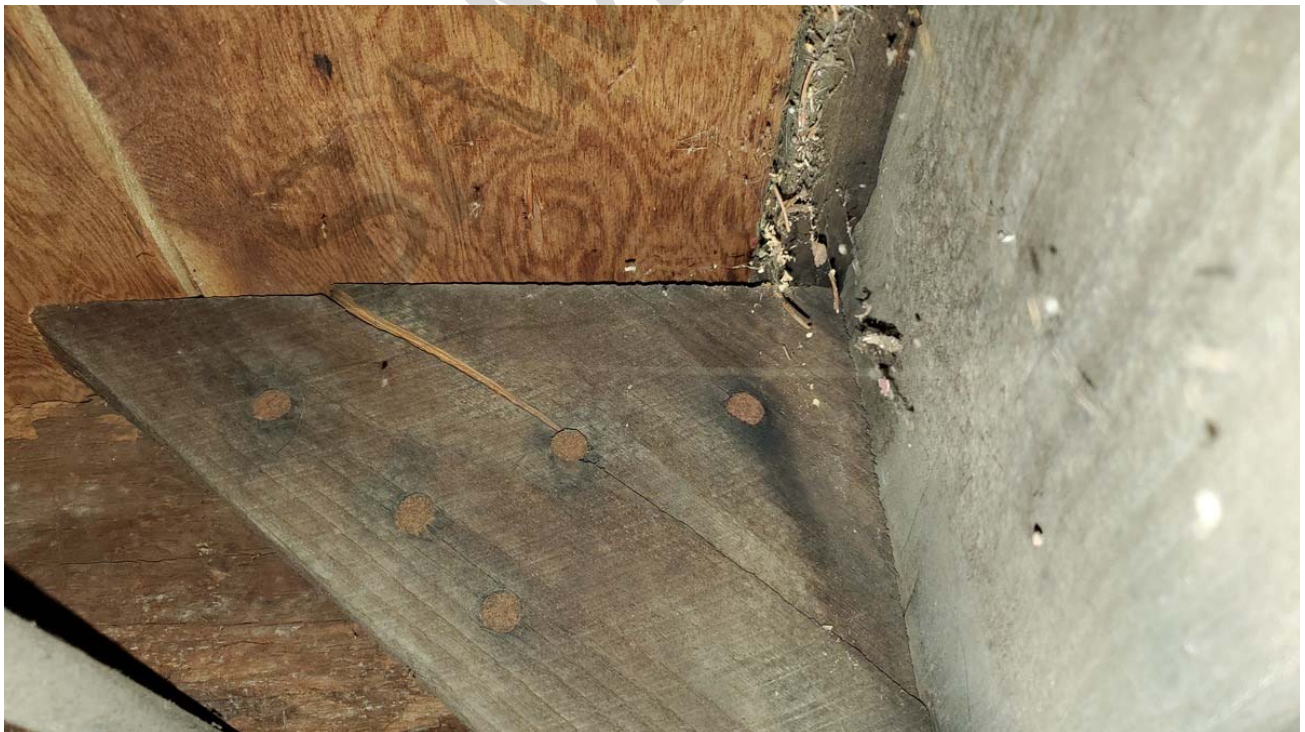
The attachment at the top of the stairs is failing. The stair stringers have been nailed into original wood timbers which have been compromised by insect damage. The nails used have caused one stair stringer to split. These stairs have a noticeable slant from side to side, and the top individual stairs also slant downward, creating an uneven and dangerous condition. (Key Plan Observation Item #11)

Failing connection at interior basement stair stringer.

The basement interior stairs should be completely reconstructed. This stair is dangerous and use should be limited until corrected.*

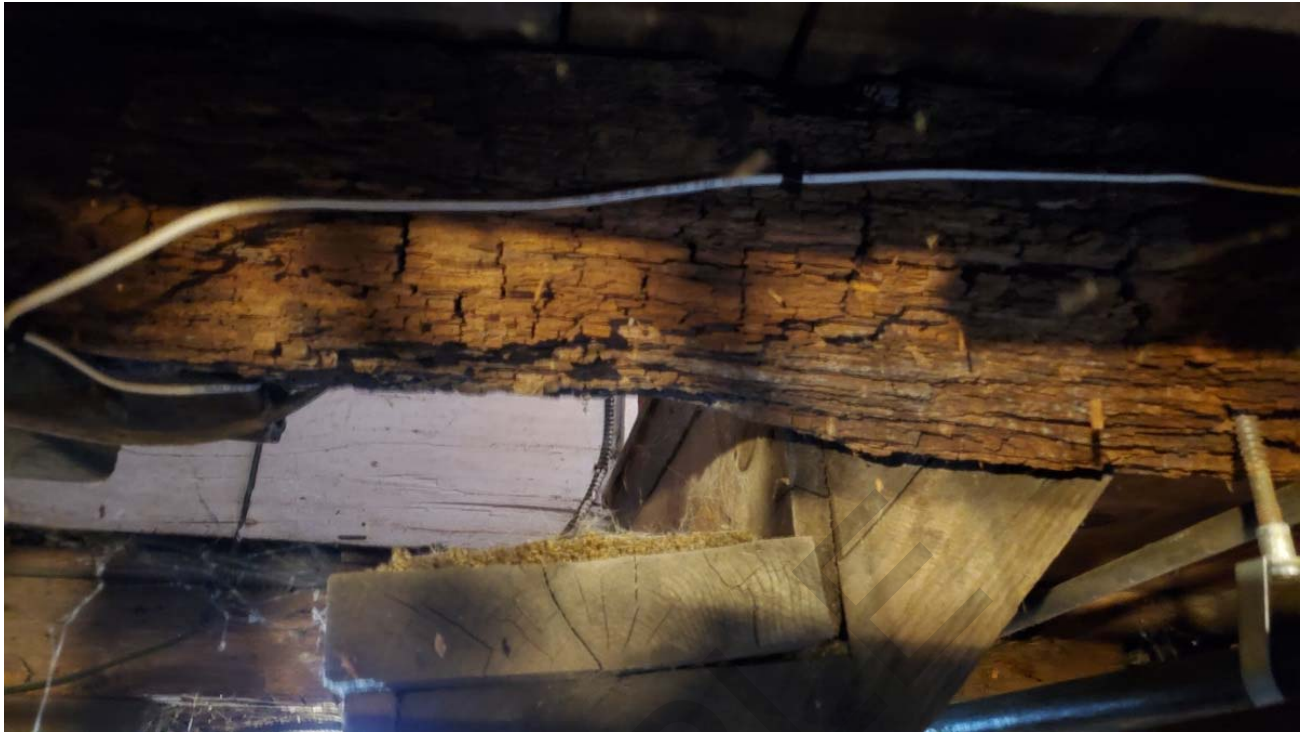
Un-level basement stair connected to insect damaged framing.

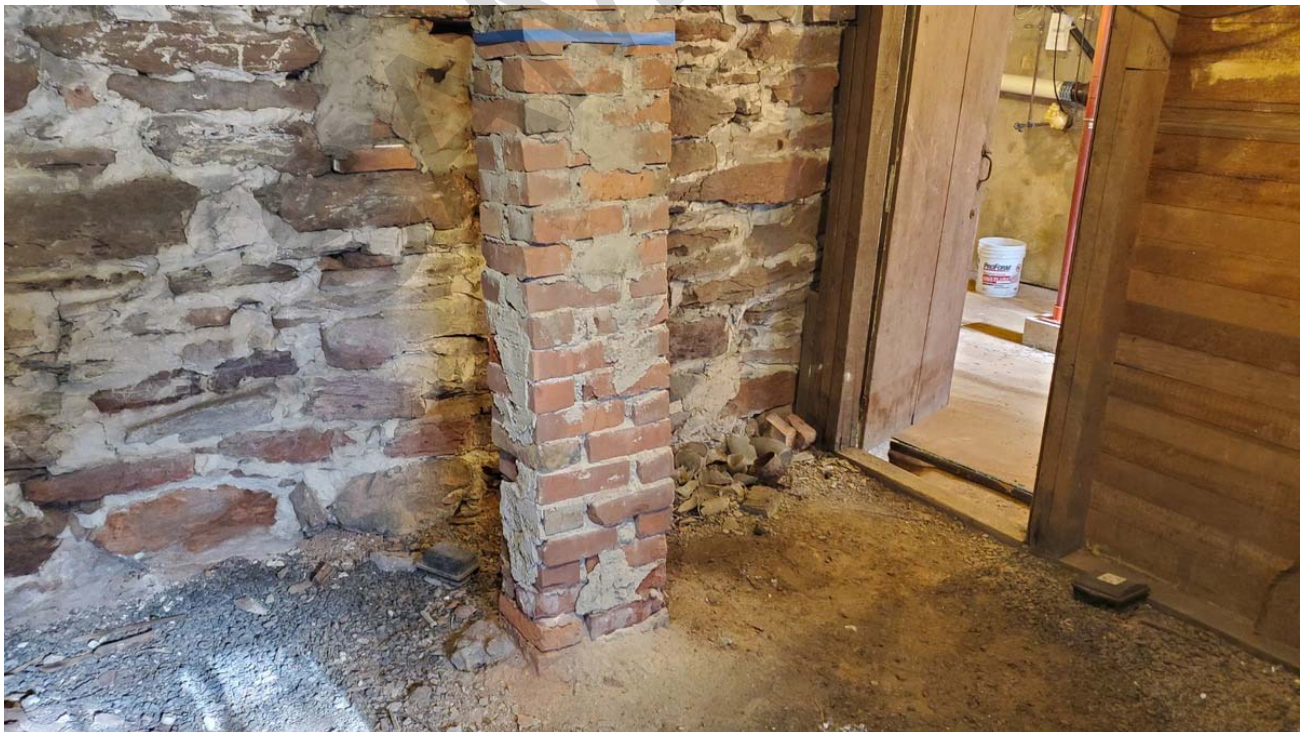
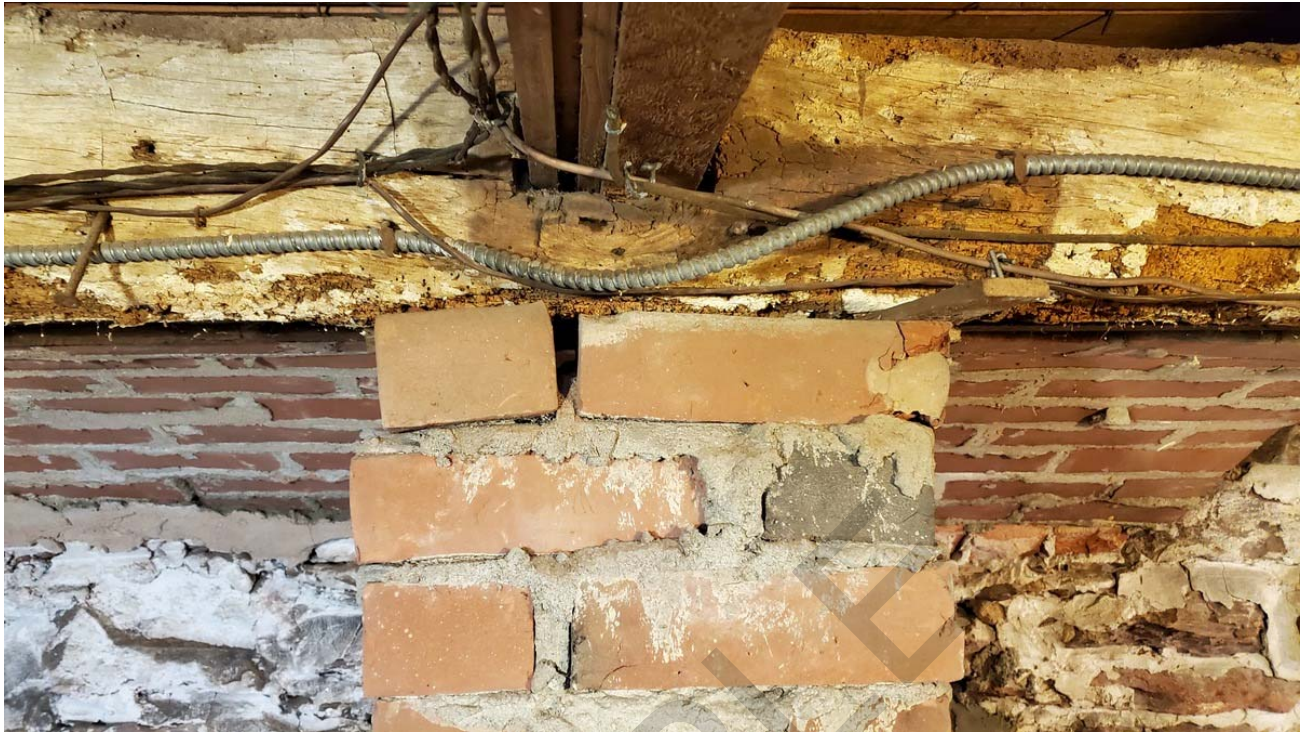
In the full height room, two brick piers were added at some point to provide additional support for the hearth area above. These piers are not properly mortared together, and are out of plumb. Temporary supports have been incorrectly added in this area in an attempt to stiffen the floor above. (Key Plan Observation Item #10)

Out-of-plumb, poorly mortared masonry piers.

In the full height room, framing supported by the masonry piers should be temporarily supported, the piers removed and replaced with properly designed columns and footings.

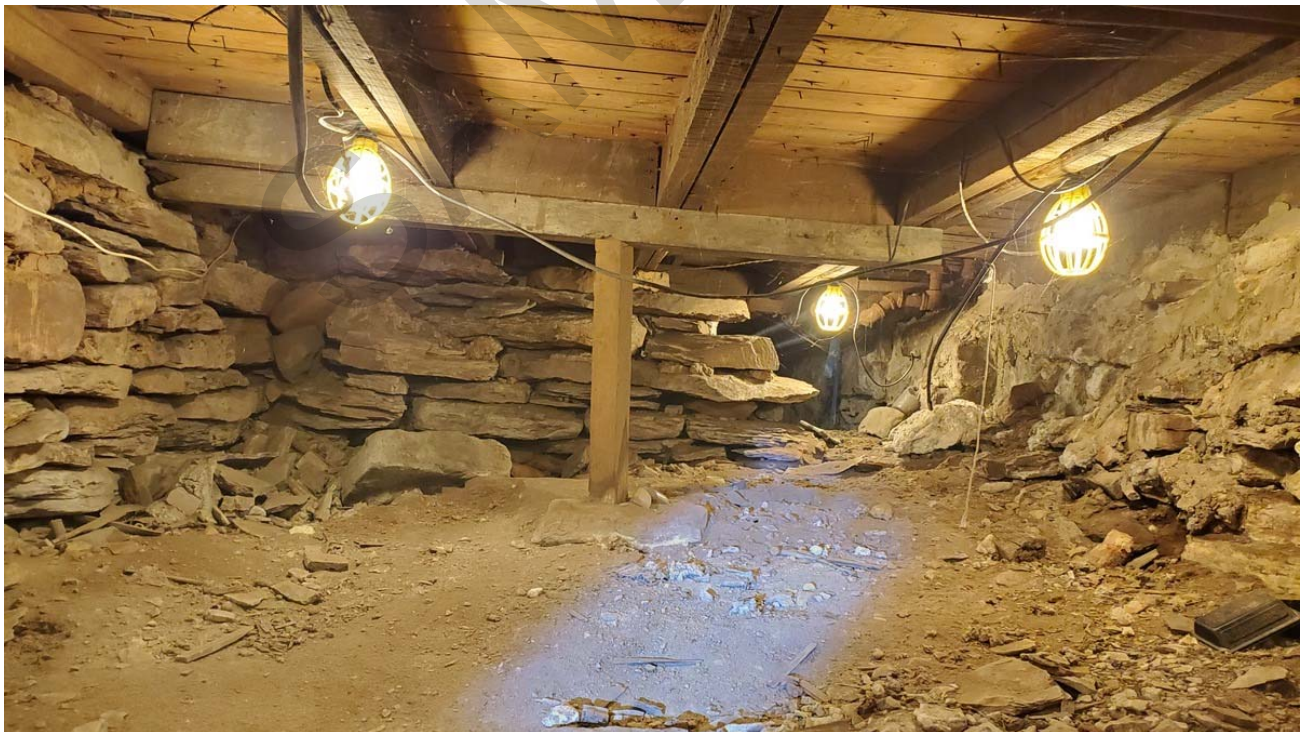
In the southern crawlspace, the first floor – floor framing has been more recently replaced. Framing in this area is comprised of double 2x members. In one area, these joists are improperly supported by a “T” configuration beam and column with no footing. (Key Plan Observation Item #10) Other framing connections in this area appeared adequate.

Southern crawlspace – poorly supported beam.

In the southern crawlspace, the improperly supported beam will require the addition of properly designed columns and footing.
