December 14, 2020

RE: 3 Avenue La, Anytown, CT.

On December 10, 2020 we visited the above referenced location to visually assess the existing residential structure for signs of any significant structural damage and/or distress. This inspection was limited to structural components accessible at the time of the inspection. The following were our findings:

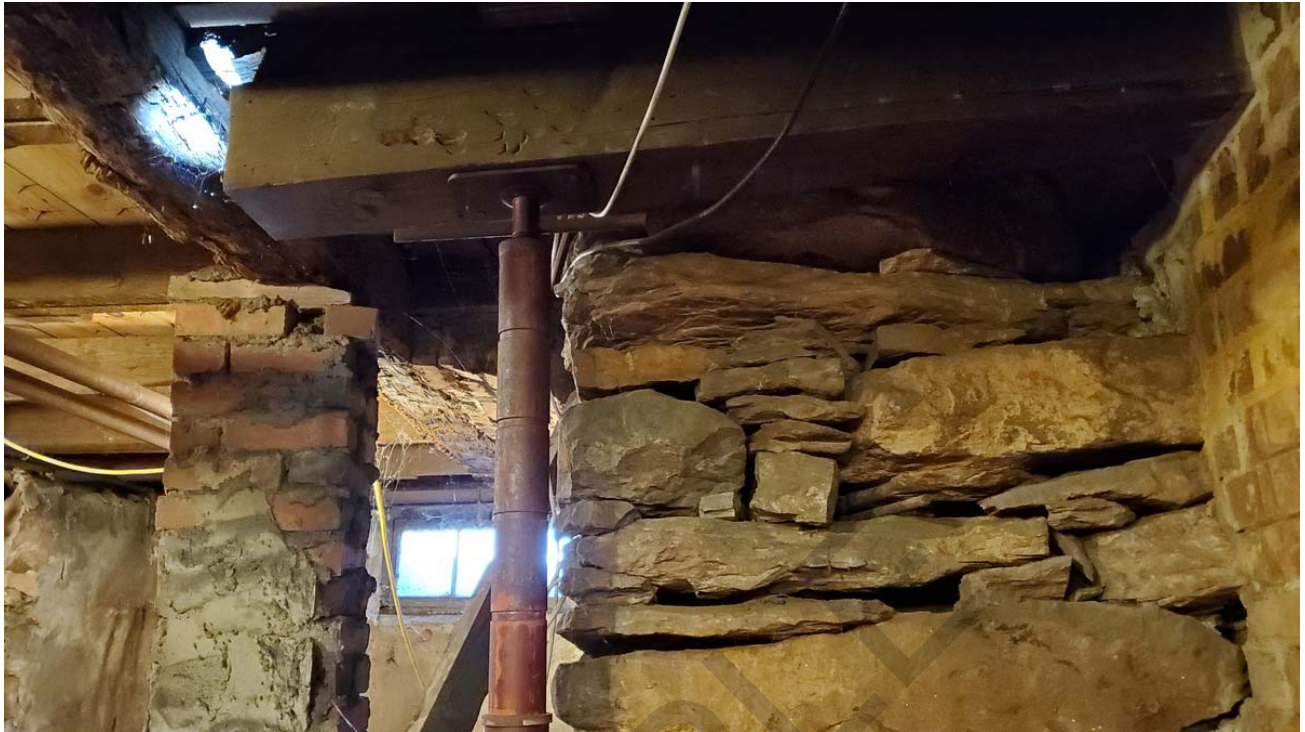
In the northern crawlspace, both original and newer framing exists. Support for one small beam at the hearth framing is improperly supported by a single adjustable column. (Key Plan Observation Item #10) A brick pier which supports one section of framing in this area is not properly mortared together, and out of plumb.

Northern crawlspace – Poorly supported beam,
Out-of-plumb, poorly mortared masonry piers,
Masonry re-pointing required.

In the northern crawlspace, framing supported by the masonry pier should be temporarily supported, the pier removed and replaced with a properly designed column and footing. The small beam will require an additional support column and footing.

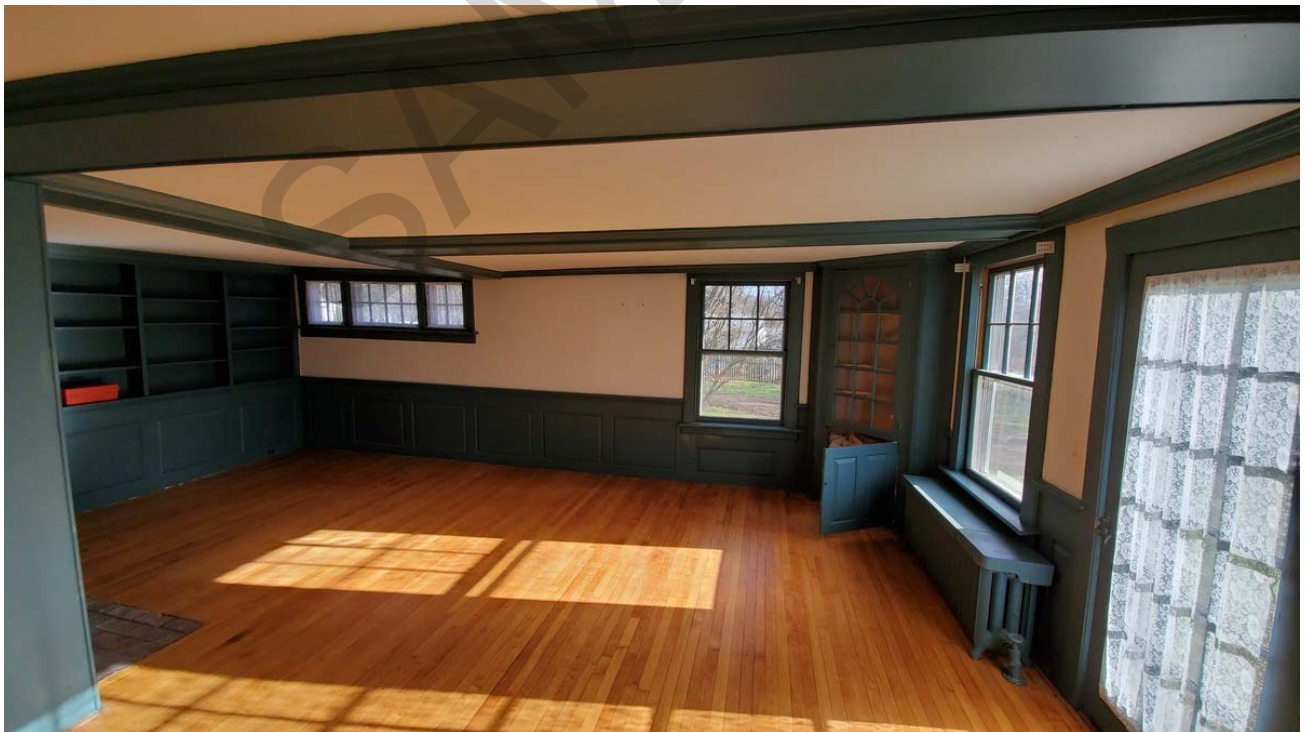
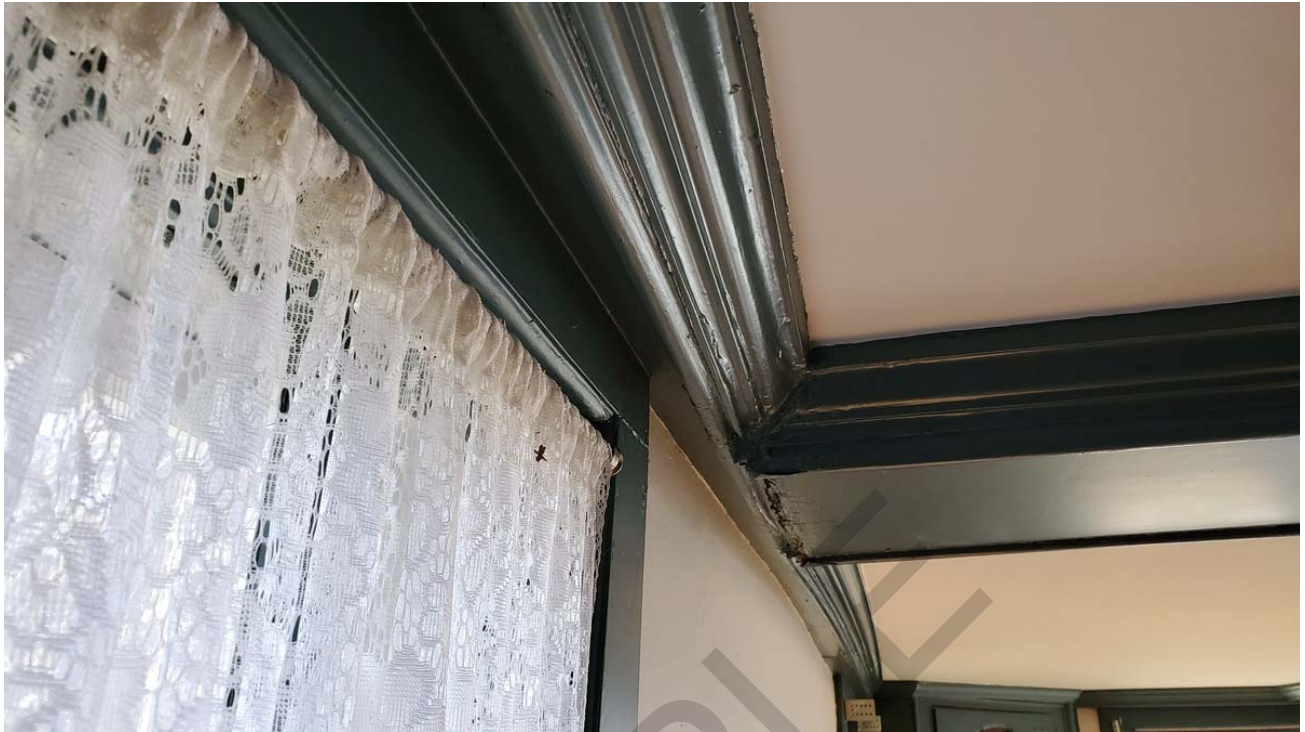
In the large room which comprises the south end of the first floor, a noticeable deflection was observed at the ceiling level of the east wall. The ceiling along the east wall deflects downward from the corners of the room to a central point where a beam intersects a post at the perimeter framing. Finish paint was cracked and displaced showing the beam has deflected downward at this intersection. (Key Plan Observation Item #13) The east wall is bowing outward at the first floor level.

Inspection of the sill area beneath this post showed signs of slight deterioration, however this did not reflect the much larger deflection at the first floor ceiling level. The beam connection to the post has likely failed in the wall at this location, and the beam is settling downward without the proper support. This was further evidenced by noticeable deflections in this area of the second floor - floor system when traversed, and cracks in the drywall above. (Key Plan Observation Item #14, #15)

Deflection at failed beam to post connection at the first floor ceiling.

The connection between a beam and post over the large room which comprises the south end of the first floor has failed. **Repair of this area will require extensive temporary shoring and removal of interior finishes in order to re-align and re-attach the exterior perimeter beam and the sagging interior beam. ***

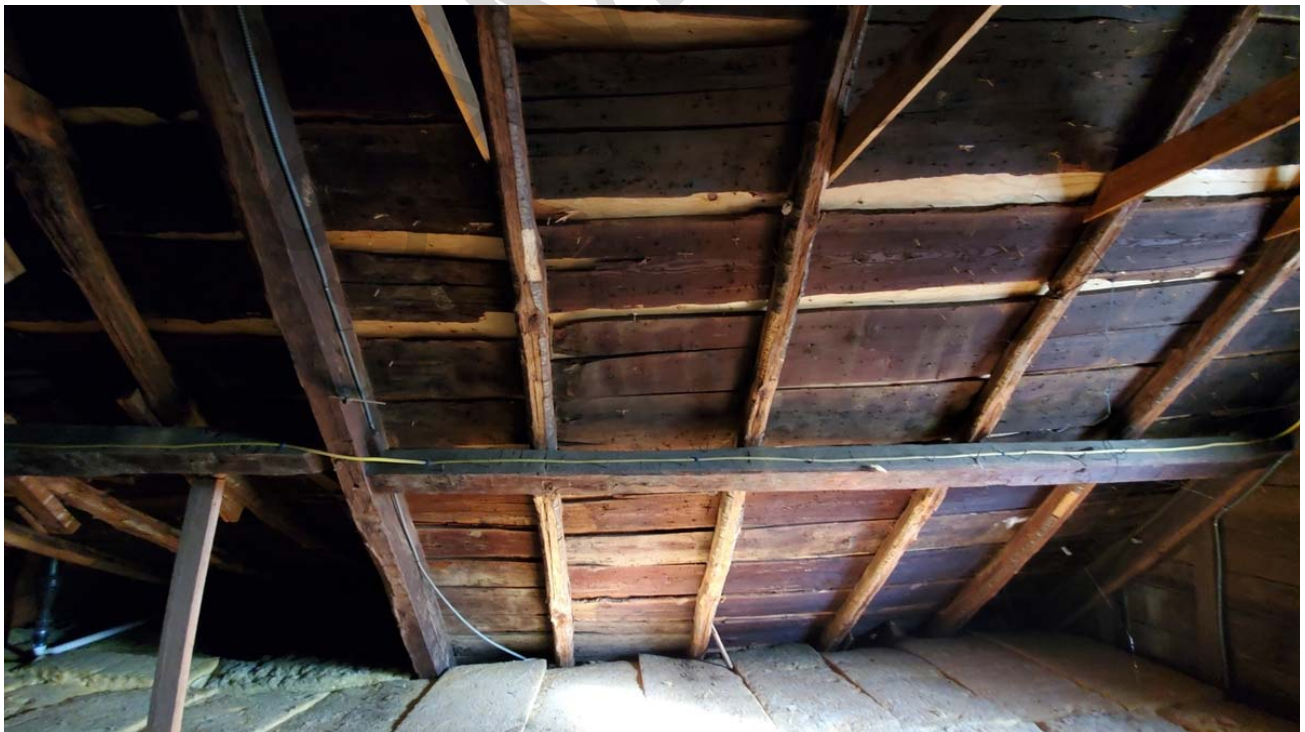
The roof framing for the main roof consists of a series of both larger diameter and smaller diameter log rafters, spaced between approximately 36" and 44" apart. Mid-span beams are connected to the larger rafters, providing support for the other, intermediate smaller rafters in the system. Deflections were observed in the rafters of this system. (Key Plan Observation Item #16)

Roof framing visible from attic.

To prevent undue settlements of the roof rafters and failure of the current support system, we recommend the sistering of existing roof rafters, and the addition of rafter between the existing rafters reducing the current spacing. Properly designed and installed rafter can eliminate the need for the center supporting beams in this system entirely, reducing additional deflections and preventing failure of this system.

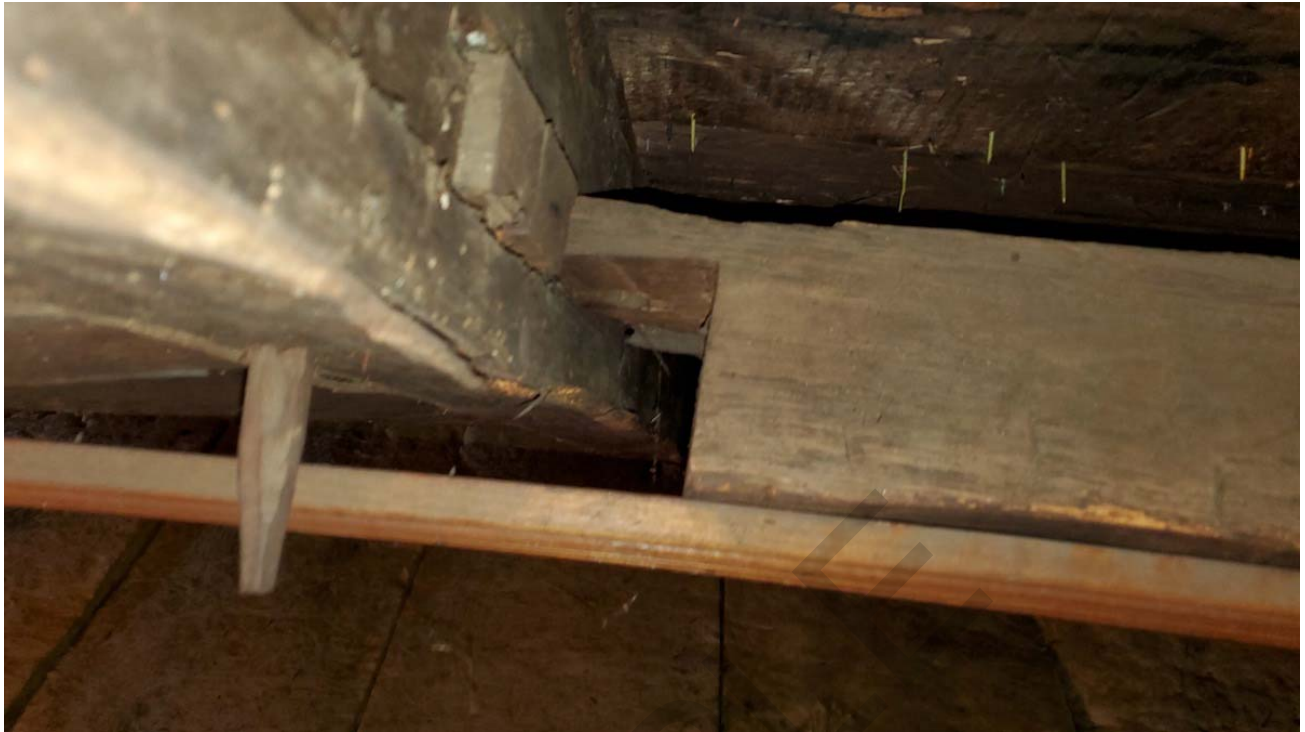
The mid-span beams have also deflected, and the connection to the larger rafters has pulled apart substantially. Connections of rafters at the ridge exhibit signs of separating. Collar ties have been installed at some roof rafters, however are not installed throughout.

Attic - Failing connection between mid-span beam and roof rafter.

Collar ties should then be added to every roof rafter in this system.

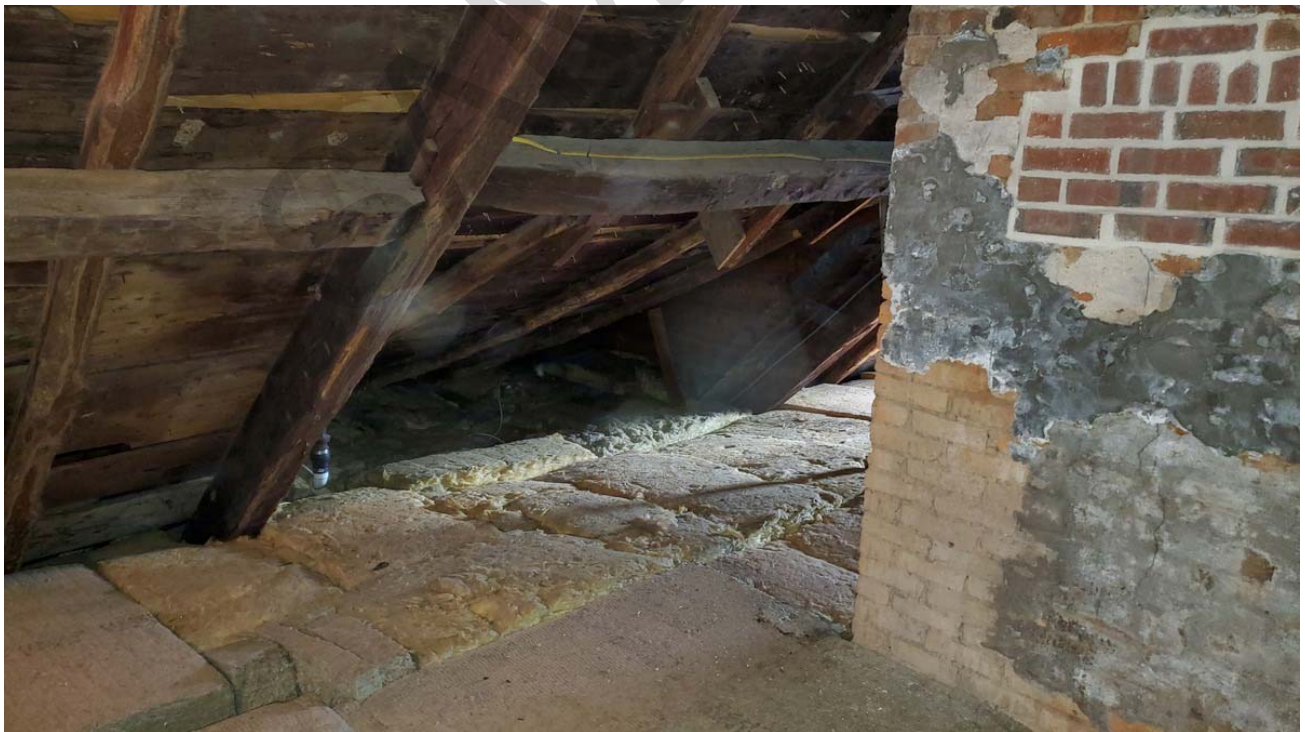
An almost full length dormer has been added to the east section of the roof. The dormer headers appear improperly constructed and exhibit signs of excessive deflection. (Key Plan Observation Item #17)

Dormer roof constructed without header.

The dormer areas should have a header added to the framing at the dormer roof junction, properly supported by additional framing.
