May 10, 2018

RE: Tree Fall Damage - Structural Assessment at xxxxxxxx Drive, Woodbridge, CT

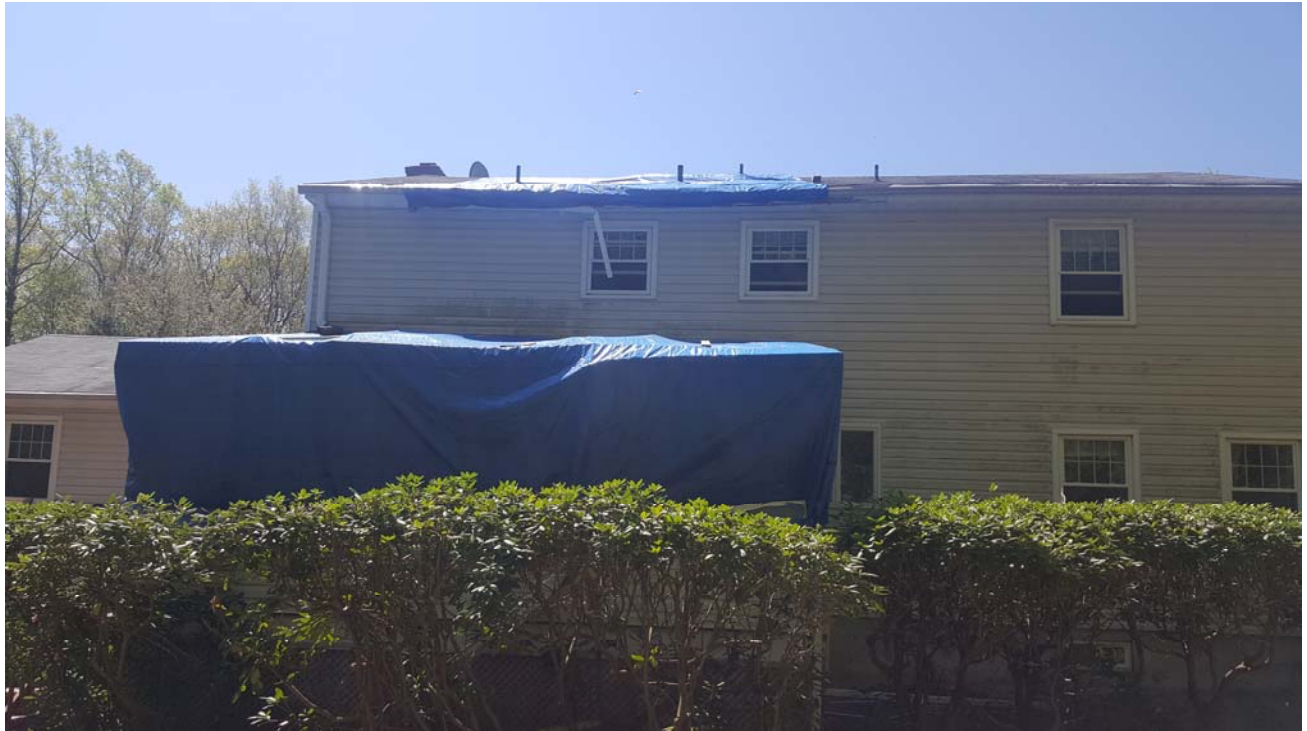
Structural damage to the residence was generally noted in three locations – The first floor attached sunroom, the main house roof, and a section of the ceiling joists at the second floor bathroom. In addition to this, water infiltration was noted in the basement, and kitchen ceiling (lowered area) as a result of this damage.

1. Overall view of Exterior Damage.

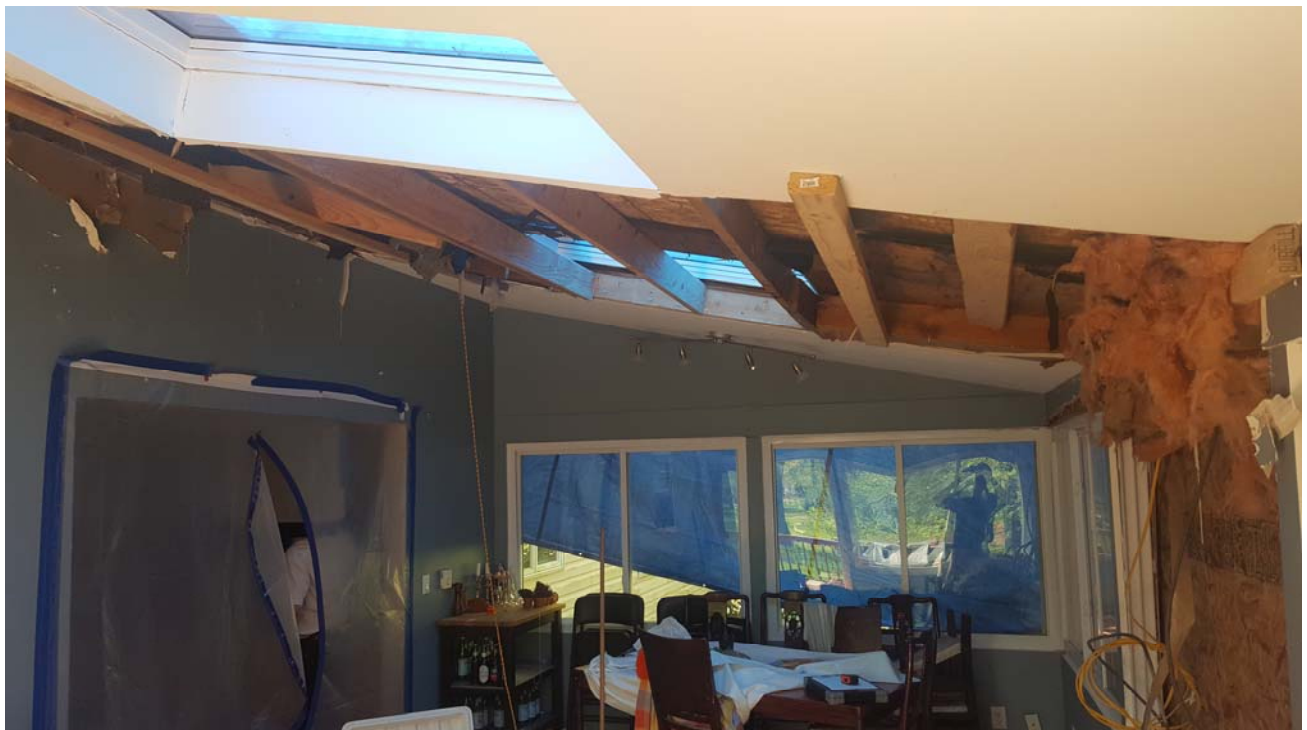
The 12' x 22' sunroom located at the rear of the main structure was most severely affected by the tree fall event. The tree impacted the rear wall and roof of the sunroom, damaging a significant area of the roof, wall, windows and skylights. The existing hardwood floor has warped due to water intrusion and is beyond repair. The windows on all three exterior walls of the sunroom are out of square, and fail to open and close properly. These gas-filled double pane windows have likely had their internal seal damaged which will eventually allow the gas to escape.

The underlying floor joists and structural support system of the sunroom were also inspected, and no signs of damage were found.

2. Damage to Sunroom.

The sunroom floor support system was unaffected by the event, however all upper portions of the structure have been severely impacted, therefore it is our recommendation that the three side walls and roof of the sunroom be removed and the sunroom rebuilt in its entirety atop the substructure. The sunroom should not be occupied until repairs are complete.

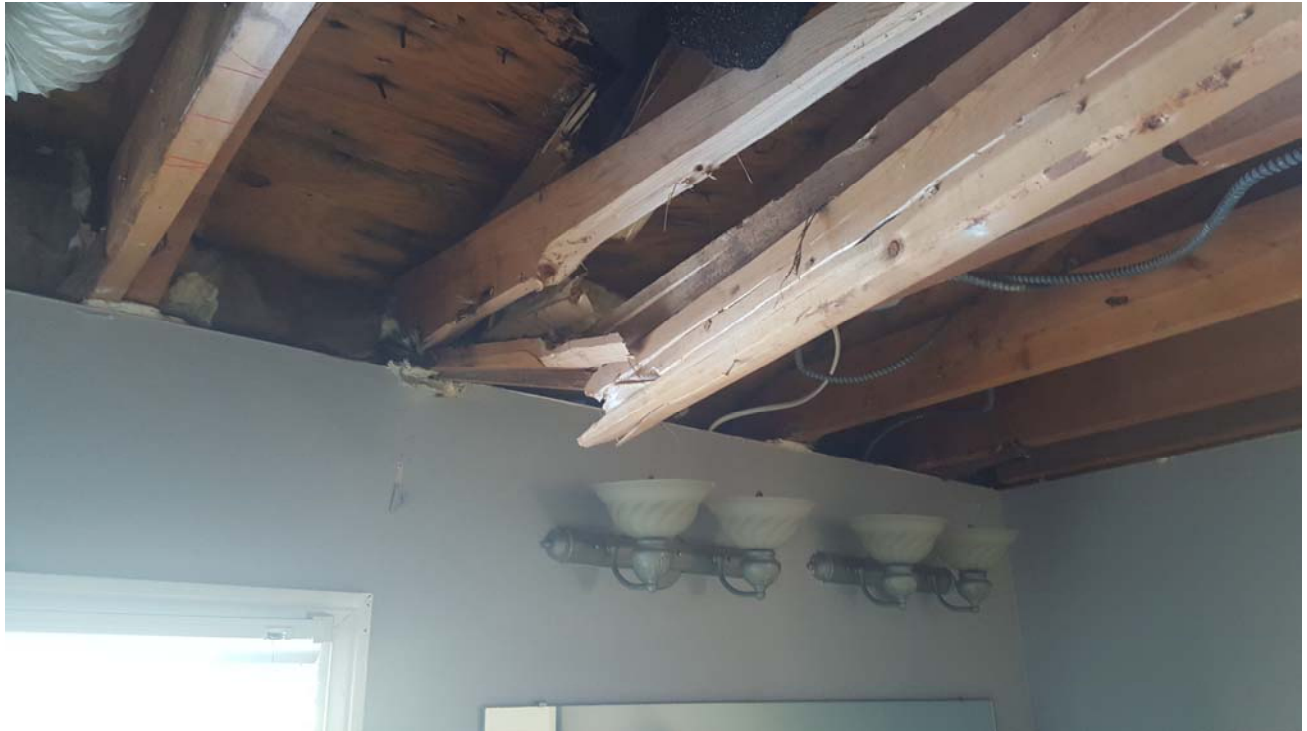
Multiple 2x6 joists at the ceiling of the second floor bathroom were affected by the impact. Additionally, there is extensive damage to the finishes and sheetrock in this bathroom.

3. Damaged joists at second floor bathroom.

The 4 affected ceiling joists in the second floor bathroom should be replaced, as well as all affected trim and finishes.

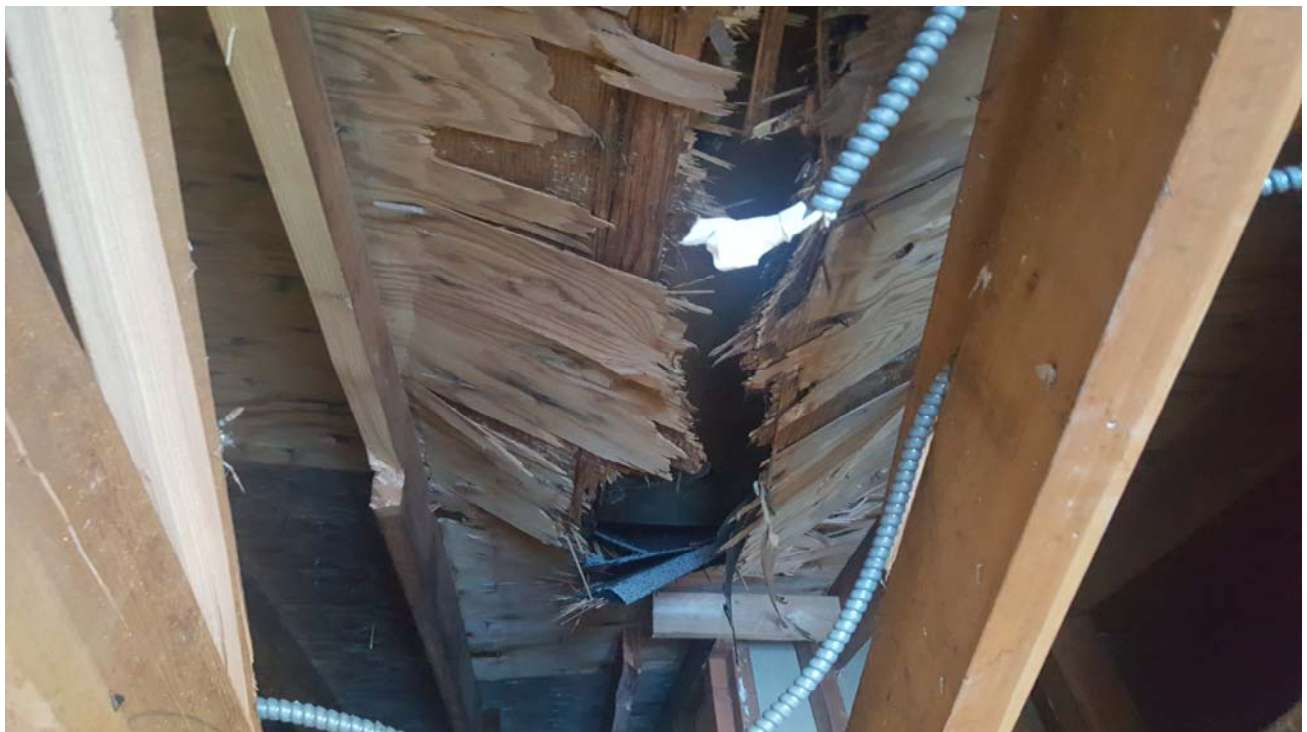
The tree penetrated the roof and the impact caused damage to the roof covering, sheathing, roof rafters and second floor ceiling joists. Located directly above the second floor bathroom, 4 existing roof rafters have been damaged. (See Photos).

4. Roof rafter and sheathing damage.

The 4 affected roof rafters in the roofing system should be replaced in kind, along with all affected bays of roof sheathing. Additionally, gutter and exterior trim will require replacement. If repairs are not immediately commenced, temporary shoring must be installed in this area.

In order to provide temporary closure to the elements and forestall greater damage, a tarp has been mechanically fastened to the roof, through the roofing material on both sides of the ridge. This will require that the entire roof be replaced once the structural repairs are completed.
